## **Spokane River Urban Waters Source Investigation and Data Analysis Progress Report (2009-2011)**

Source Tracing for PCB, PBDE, Dioxin/Furan, Lead, Cadmium, and Zinc

September 2012

Publication No. 12-04-025

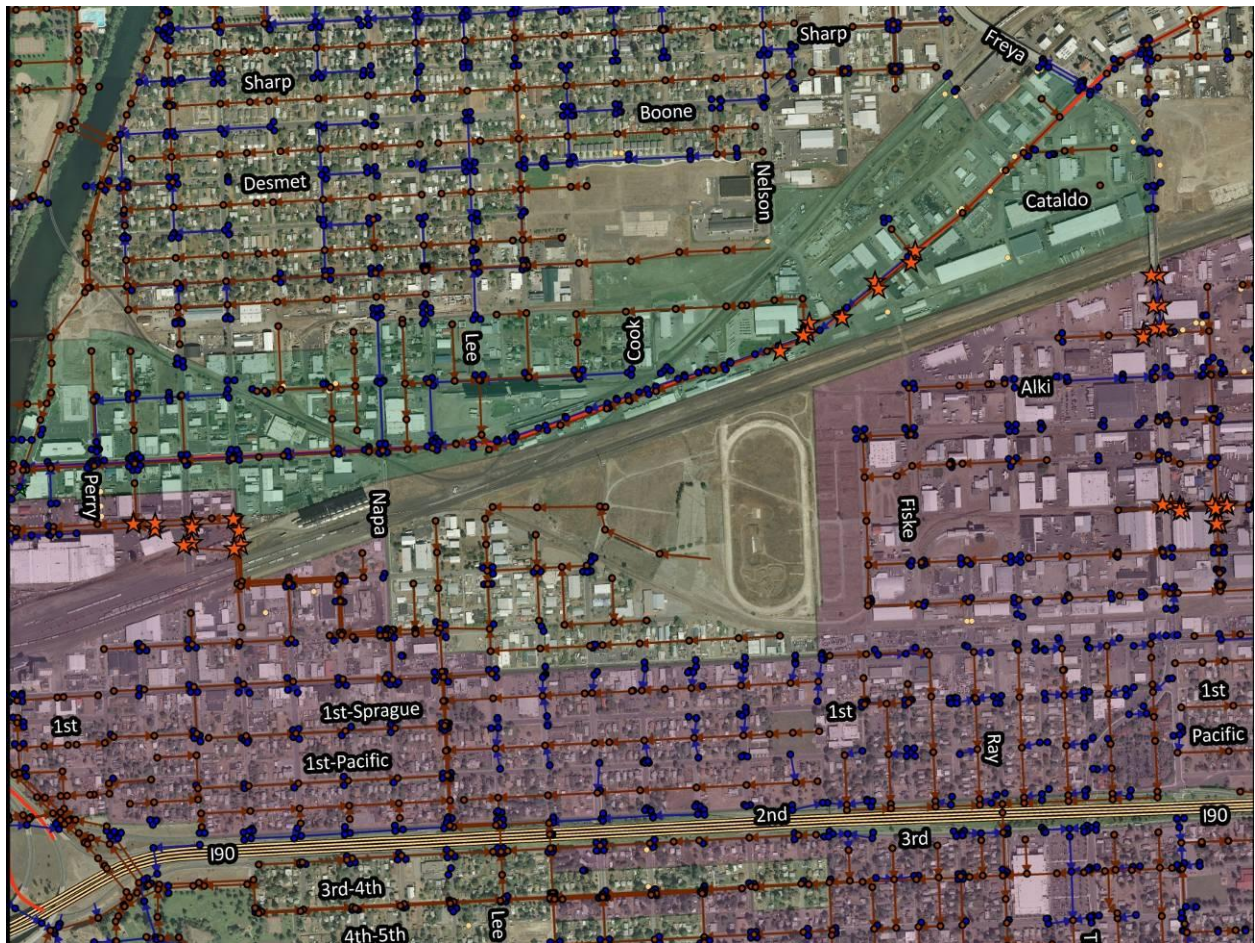
**Figure 4.** Spokane catch basin locations where the city found elevated PCB concentrations. Catch basins under investigation are denoted by orange stars.

Spokane conducted source tracing and elimination work for PCB within their storm system. Because Union basin was one of the known contaminated discharges, they began their work in this basin approximately one year after we started. They collected sediment from catch basins and their connected drywells while Urban Waters worked with businesses on compliance. The City also completed several system modifications to reduce turbidity, which should also reduce any river PCB contamination due to air deposition and any unknown sources discharging to the system.

The hot spots in figure 4 came from Spokane's initial EPA Method 8082 aroclor analysis screen. Recent work by Spokane showed duplicate samples analyzed using EPA Method 1668 revealed a different set of hot spots (City of Spokane, 2012). Future efforts will take into account the 1668 locations and modify our source tracking efforts accordingly.

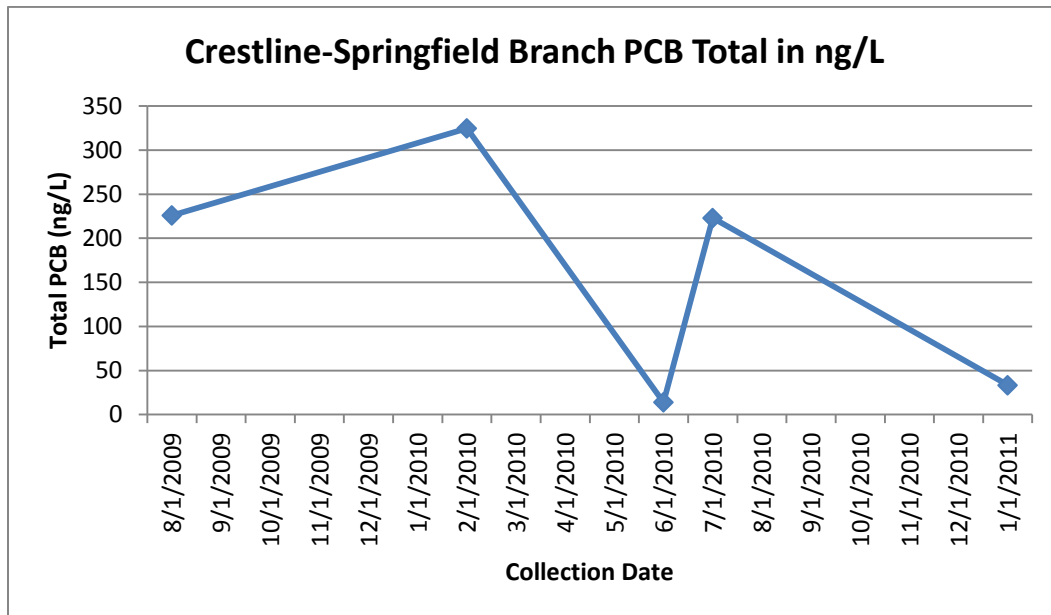
**Figure 5.** Total PCB concentrations at Crestline-Springfield branch over time.

The LSCS identified a City street drywell with overflow to Union basin near the southwest corner of the City Parcel property as a possible conduit of PCB to the river. A sediment sample from the connected drywell at the corner of Cook St. and Springfield Ave. (Cook-Sprg) showed a concentration of 980,000 ng/Kg total PCB. The stormwater in-pipe concentration (CRSPADM and CR/ADM) was 226 ng/L. The City cleaned out the system. Subsequent stormwater sampling showed a general lowering in concentration over the next year (Figure 5).

The elevated in-pipe water sample result obtained on July 2010 prompted us to reinvestigate the site for additional sources. Spokane disconnected the drywell from the system on December 14, 2011 to prevent any further discharge to the river. We will collect an additional branch sample to confirm sources have been eliminated.

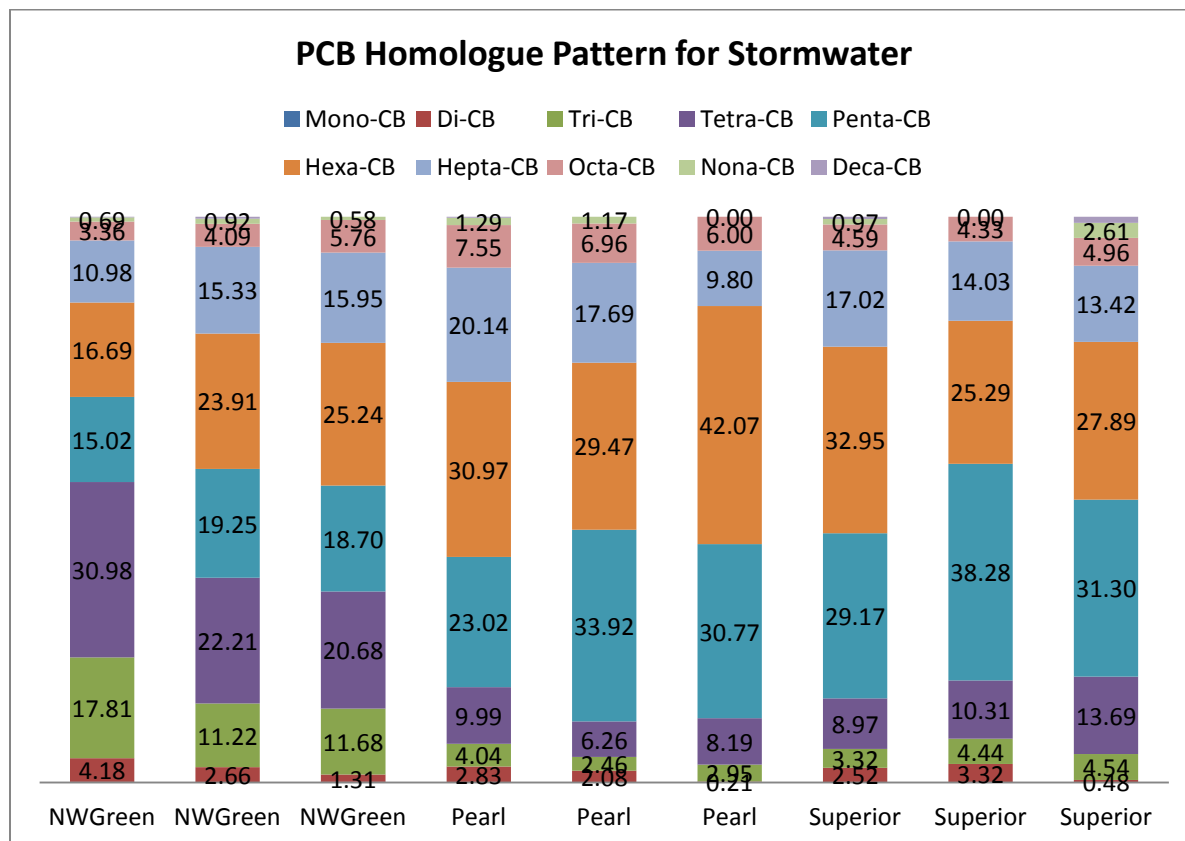
**Figure 9.** PCB homologue patterns for stormwater from three basins.

As an example of some additional patterns we can look for, Figure 9 displays three storm results for three sites. In addition to the shift from the Union outfall pattern, dominated by hexa-CB and hepta-CB homologues, the three stormwater basin outfall locations below revealed a penta-CB and hexa-CB dominant or a tetra-CB, penta-CB, and hexa-CB dominant mixture. These are more similar to our Napa-Springfield pattern and may have a similar source.

In addition, patterns stayed similar through all three storms for Pearl and Superior, while NWGreen showed a change in pattern. This may indicate more than one source.

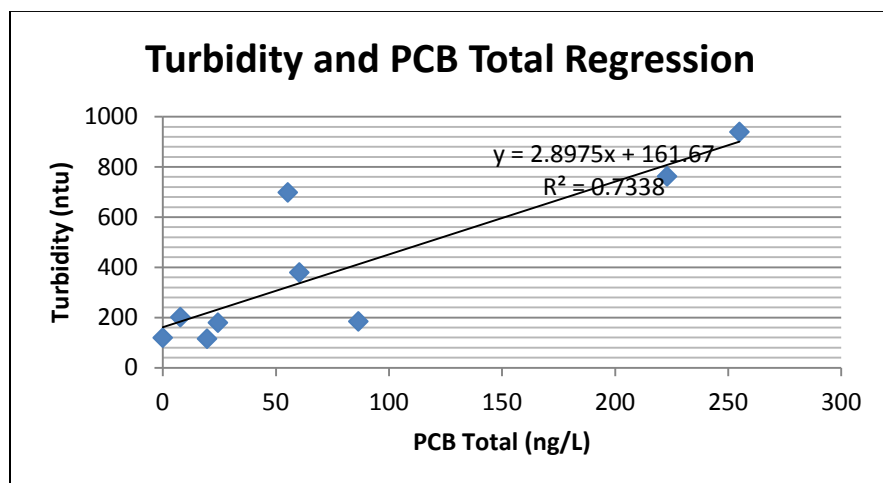
**Figure 10.** Linear regression of turbidity and PCB in stormwater.

Because the regression appears strongly influenced by two data points, additional data points should be collected to confirm this association.

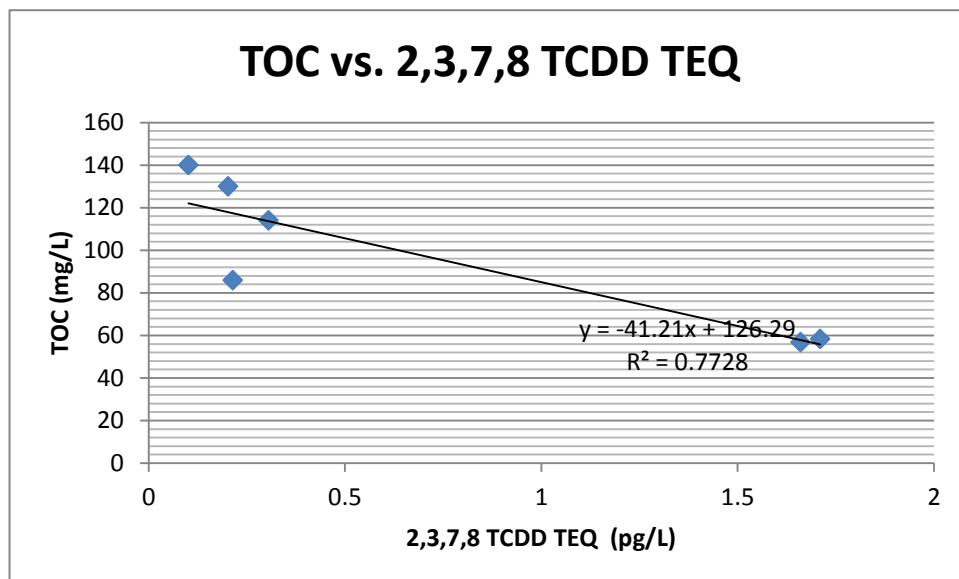
**Figure 11.** TOC vs. total dioxin/furan TEQ linear regression.

Linear regression analysis suggests a strong inverse association between 2,3,7,8 TCDD TEQ and TOC in sanitary sewer (Figure 11). The sample number is low, however, and further data collection is necessary (N=6). No association was found between TSS and dioxin/furan in sanitary sewer.

Because the regression appears strongly influenced by two data points, additional data points should be collected to confirm this association to use for source tracing purposes. For example, high TOC may be used as an inexpensive screen for dioxin/furan unless other investigative factors indicate otherwise. This may influence a fate and transport model for this system. If we can determine the significant source of TOC, such as human waste, we can focus our surface investigations accordingly.

- An association was found between 2,3,7,8 TCDD TEQ and TOC in sanitary sewer wastewater. Further investigation needs to be conducted into the significance of this finding with respect to source identification needs.
